Collision with terrain involving de Havilland DH-82, VH-BJE

Redcliffe Airport, Queensland, 3 April 2016

ATSB Transport Safety Report
Aviation Occurrence Investigation
AO-2016-030
Final – 25 August 2016

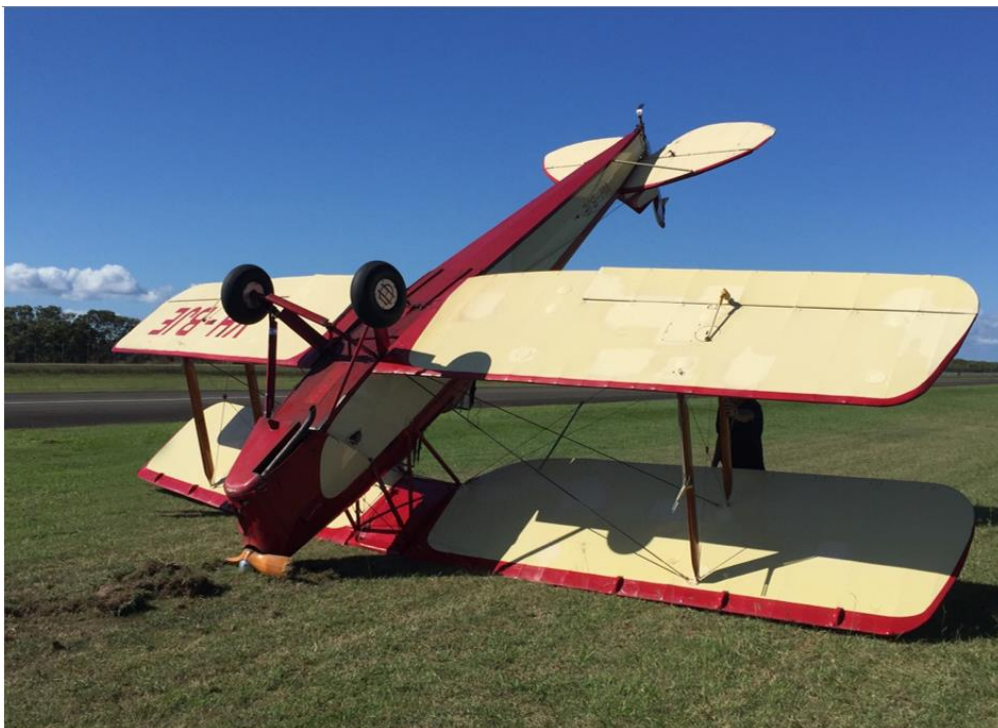
Figure 1: Accident site showing damage to VH-BJE

As the aircraft landed, the pilot reported the tail was slightly higher than normal, but the aircraft's speed was normal. The aircraft wheels touched down at the pilot's aiming point, about half way along the grass strip to the right of the sealed runway. The pilot reported that the wheels seemed to dig in. The aircraft nose pitched down, the propeller struck the grass runway, and the aircraft rolled over forwards, coming to rest inverted (Figure 1).

The pilot and passenger were uninjured. The aircraft sustained substantial damage.

The pilot commented that the ground was a bit soft where the wheels had touched down, but that they had landed there twice previously that day without incident. In future, the pilot would land with a slightly higher nose attitude.
