ATSB TRANSPORT SAFETY INVESTIGATION REPORT

Aviation Research and Analysis Report – B2005/0055

Wire-strike Accidents in General Aviation: Data Analysis 1994 to 2004

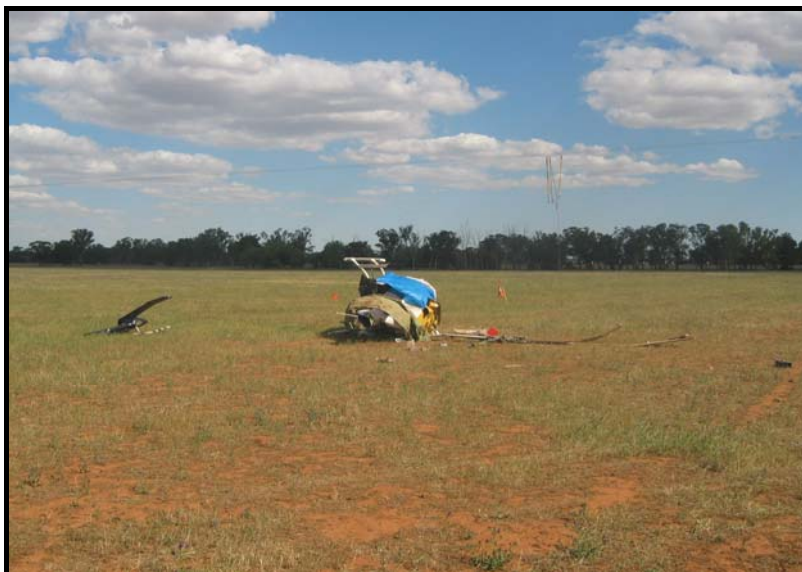
Figure 1: Bell 206B helicopter after striking powerlines during a locust control campaign near Forbes on 31 October 2004

- An accident involving a Bell 206B helicopter conducting aerial work near Forbes, New South Wales on 31 October 2004 in support of the Forbes area locust control campaign. The accident resulted in minor injuries to one passenger and extensive damage to the helicopter (ATSB Report: 200404285). The aircraft is pictured in Figure 1.

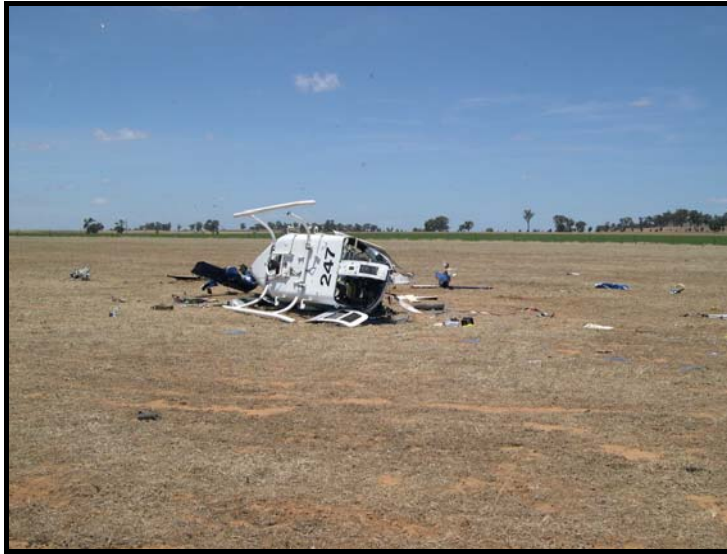
Figure 2: Bell 206B helicopter after striking powerlines during a locust control campaign near Dunedoo on 22 November 2004

- An accident involving a Bell 206B helicopter conducting aerial work near Dunedoo, New South Wales on 22 November 2004 in support of the Dubbo area locust control campaign. The accident resulted in fatal injuries to the pilot and one passenger, serious injuries to another passenger, and extensive damage to the helicopter. (ATSB Report: 200404590). The aircraft is pictured in Figure 2.

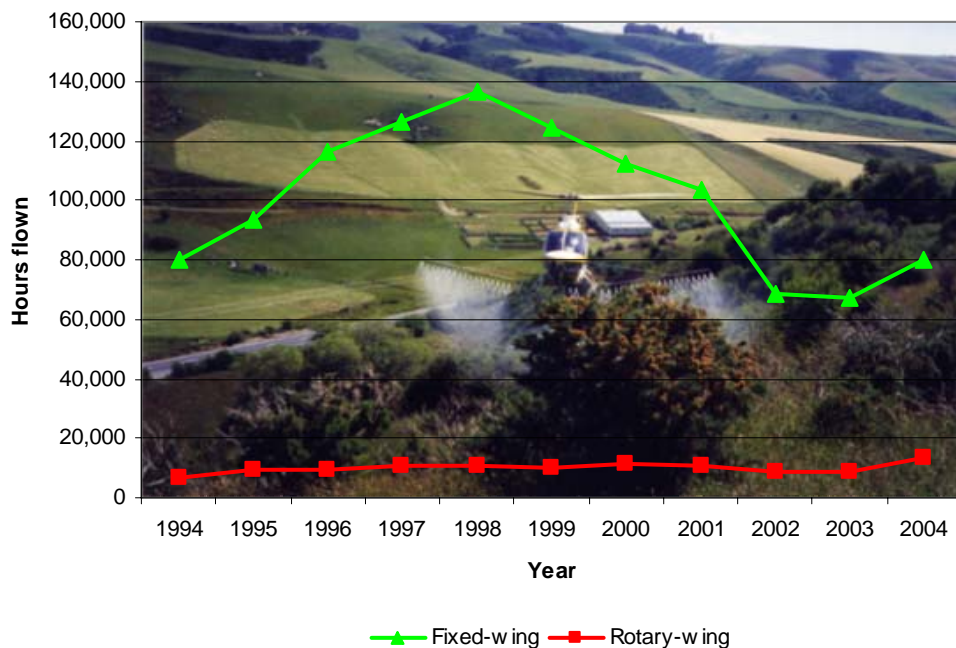
Figure 4: Hours flown in aerial agriculture operations, 1994 to 2004

Figure 4 shows the hours flown in fixed-wing and rotary-wing aircraft for aerial agriculture operations between 1994 and 2004. During this period, 91 per cent of all aerial agriculture operations were performed in fixed-wing aircraft. The remaining nine per cent were performed in rotary-wing aircraft.

The average yearly flying hours for agricultural operations between 1994 and 2001 was 110,600 hours. This number reduced to around 70,000 hours during the drought of 2002 and 2003. A slight recovery was experienced in hours flown for both fixed-wing and rotary-wing aircraft in 2004, to just over 93,000 hours in total.

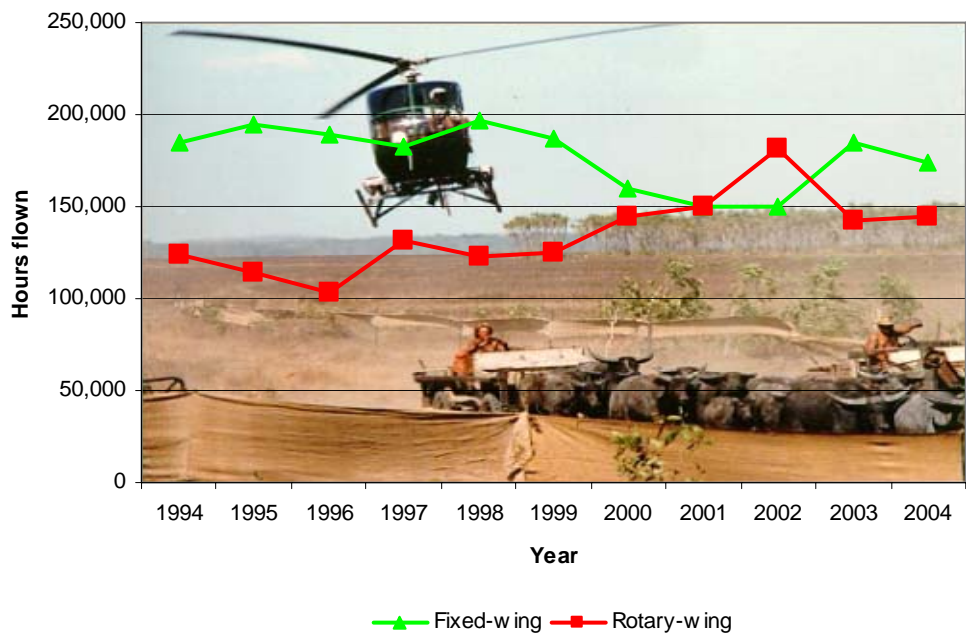
Figure 5: Hours flown involving other aerial work operations, 1994 to 2004

Figure 5 shows the hours flown in fixed-wing and rotary-wing aircraft for other aerial work operations between 1994 and 2004. Fixed-wing aircraft accounted for an average of 57 per cent of all other aerial work operations during the reporting period, while rotary-wing aircraft accounted for the remaining 43 per cent.

Fixed-wing activity varied across the reporting period, ranging from around 150,000 hours annually to nearly 200,000 hours annually. Rotary-wing aircraft have become increasingly popular for other aerial operations, and in 2002 exceeded the number of hours flown by fixed-wing aircraft.

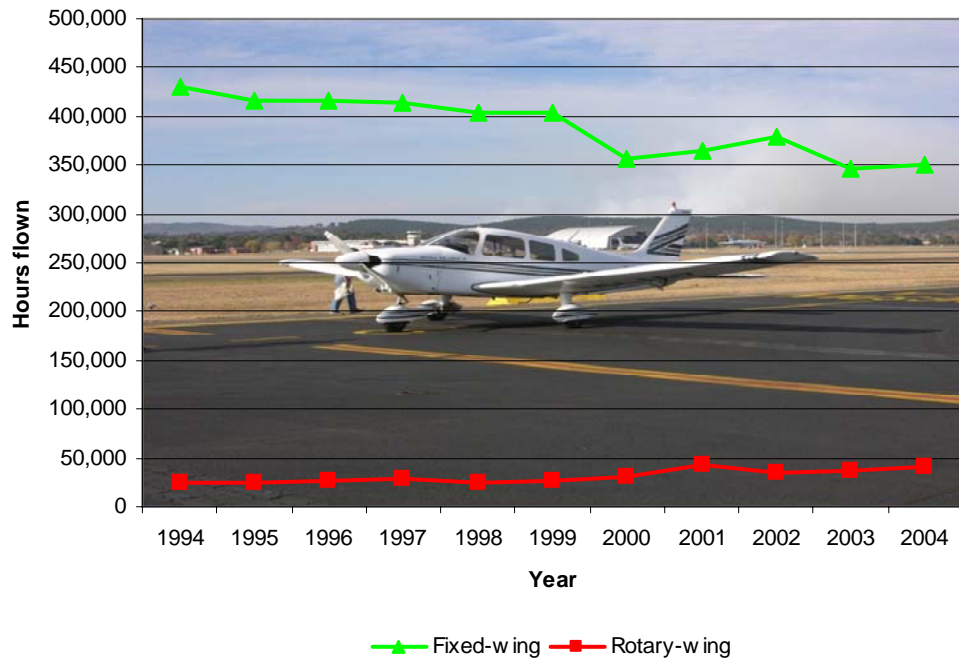
Figure 6: Hours flown for private/business operations, 1994 to 2004

Figure 6 shows the hours flown in fixed-wing and rotary-wing aircraft for private/business operations between 1994 and 2004. During this period, 93 per cent of private/business operations were performed in fixed-wing aircraft while the remaining seven per cent were performed in rotary-wing aircraft.

The use of helicopters for private/business operations has steadily increased over the years from 25,377 hours in 1994 to 40,009 hours in 2004. While rotary-wing aircraft represent only seven per cent of all private/business operations, this represents a 58 per cent increase over the reporting period.

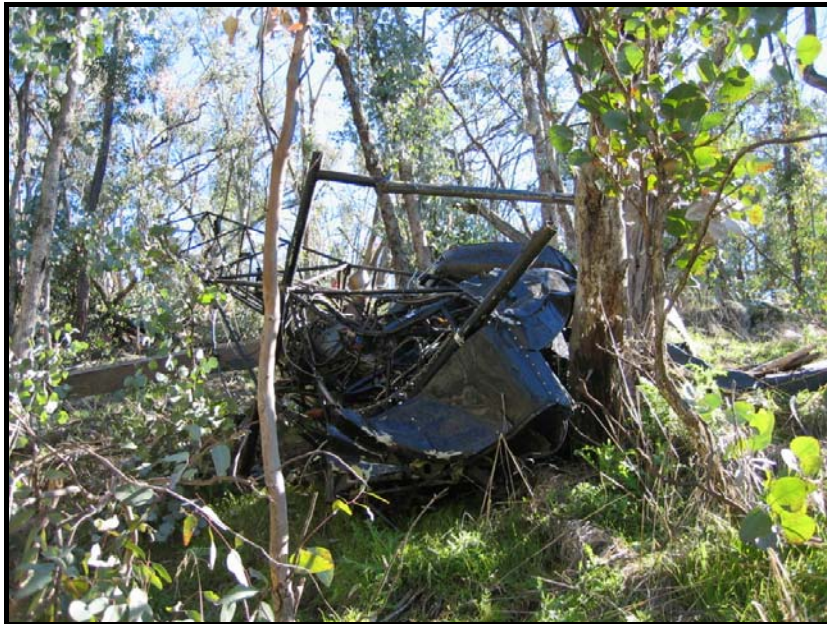
Figure 7: Bell 47G-3B-1 Soloy helicopter after striking powerlines near Wodonga on 19 June 2004

Figure 7 shows the devastating consequences of an accident involving a Bell 47G-3B-1 Soloy¹⁵ helicopter near Wodonga in Victoria that occurred on 19 June 2004. The pilot was the sole occupant and was fatally injured. The operator of the aircraft was contracted to spray herbicide on a property in Victoria, where it collided with powerlines 12 km west of Wodonga. The powerlines '... consisted of two parallel three-strand lightweight high-tensile steel cables, each of 2.75 mm diameter.' A photo of the damaged wires is presented in Figure 8. The powerlines were located on the north-eastern side of a ridgeline, strung across a direct track from the spray area to the replenishment truck (Figure 9). The full investigation report is available on the ATSB website (ATSB Report: 200402669).

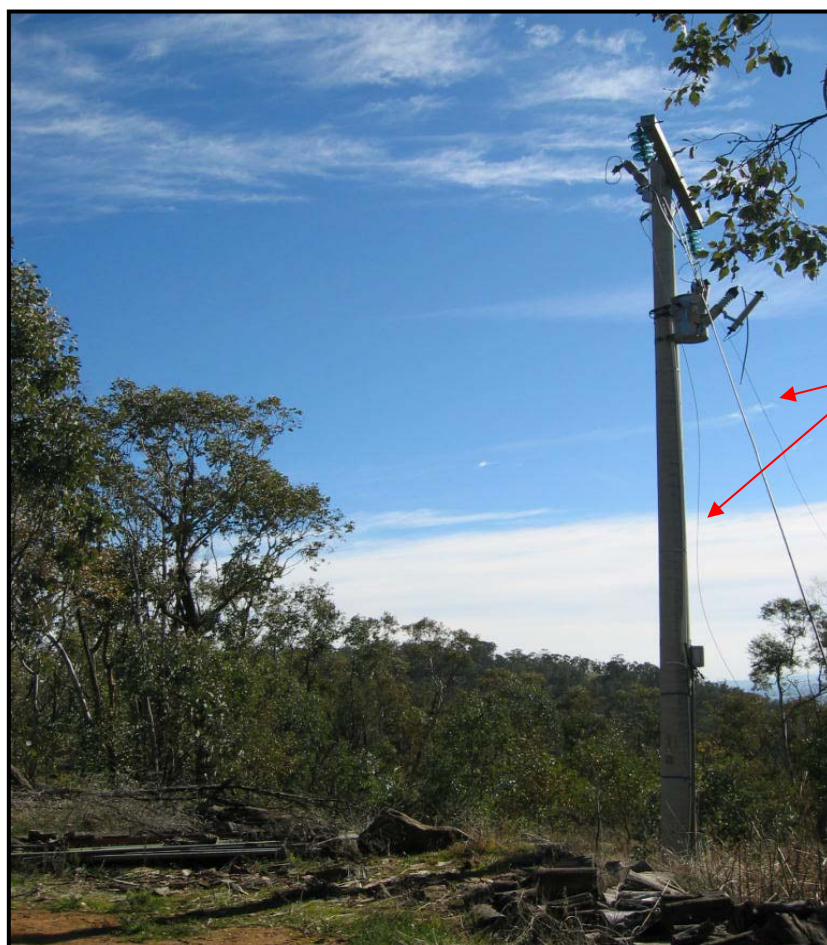
Figure 8: Damaged powerlines after being struck by the Bell 47G-3B-1 Soloy helicopter

Damaged powerlines

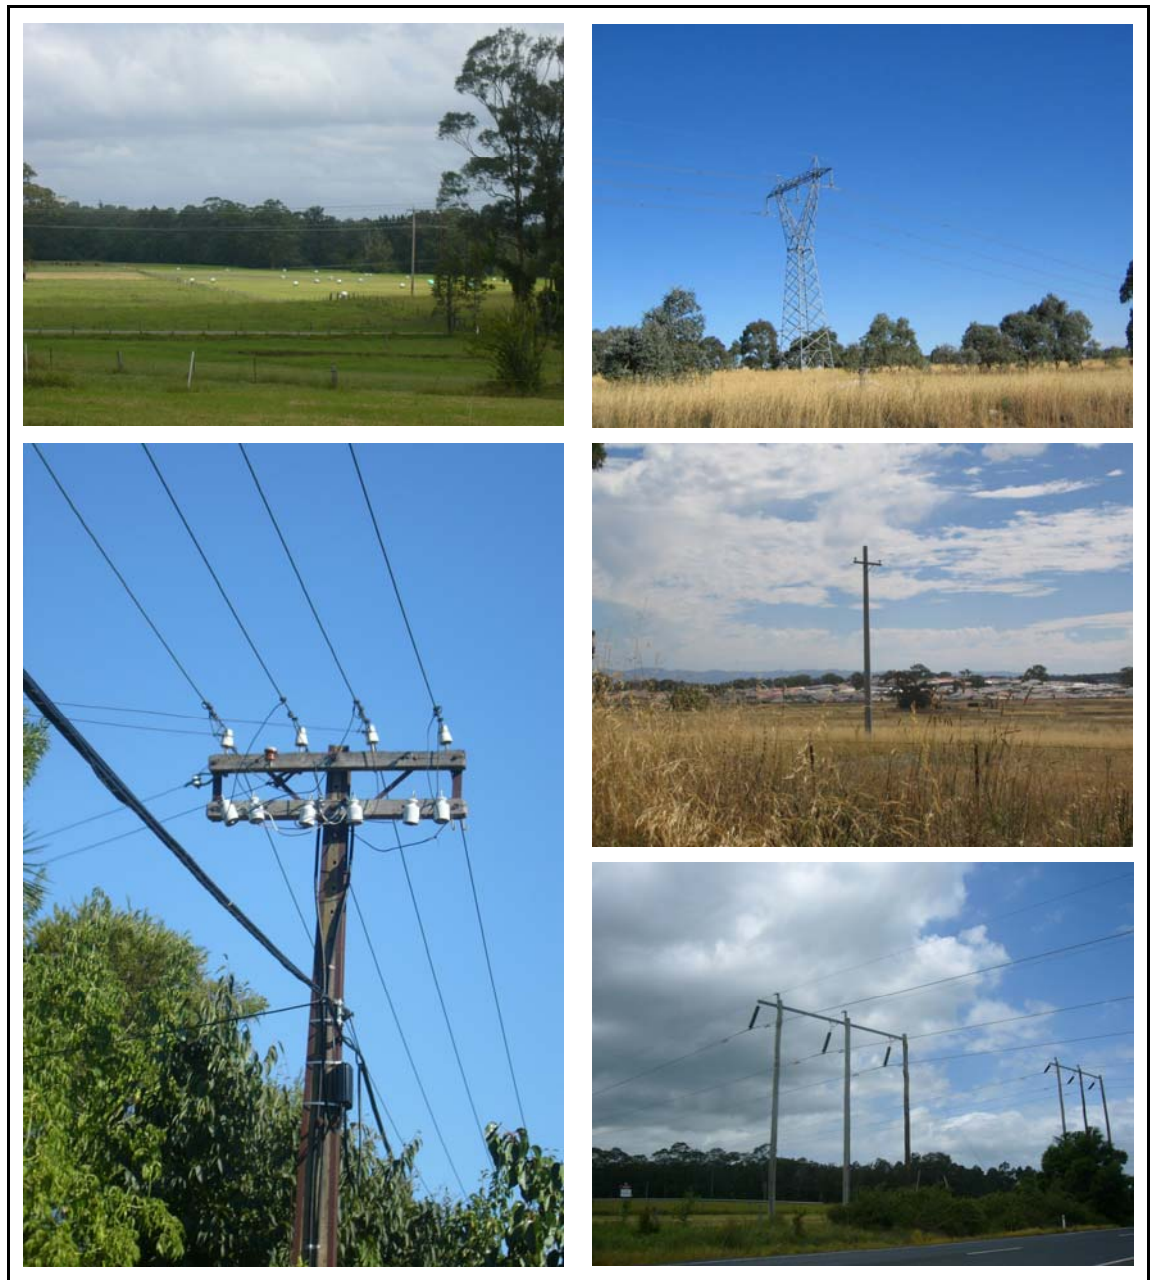
Figure 10: Examples of powerline arrangements in New South Wales

Powerlines have various configurations that range from multiple clusters of high voltage wires carried on large lattice type towers, to a single wire earth return (SWER) system. The former are high tensile heavy gauge wires that may be found at heights in excess of 100 feet AGL. Figures 10 shows examples of various powerline arrangements in New South Wales.

The SWER system is characterised by only one wire. It can be strung in spans of up to 400 metres. The system is particularly hazardous to pilots, as both the wire and the supporting poles may be difficult to distinguish from the background environment. Furthermore, these wires are often found across the approach path to a country paddock or airstrip (Freeman, 1995).

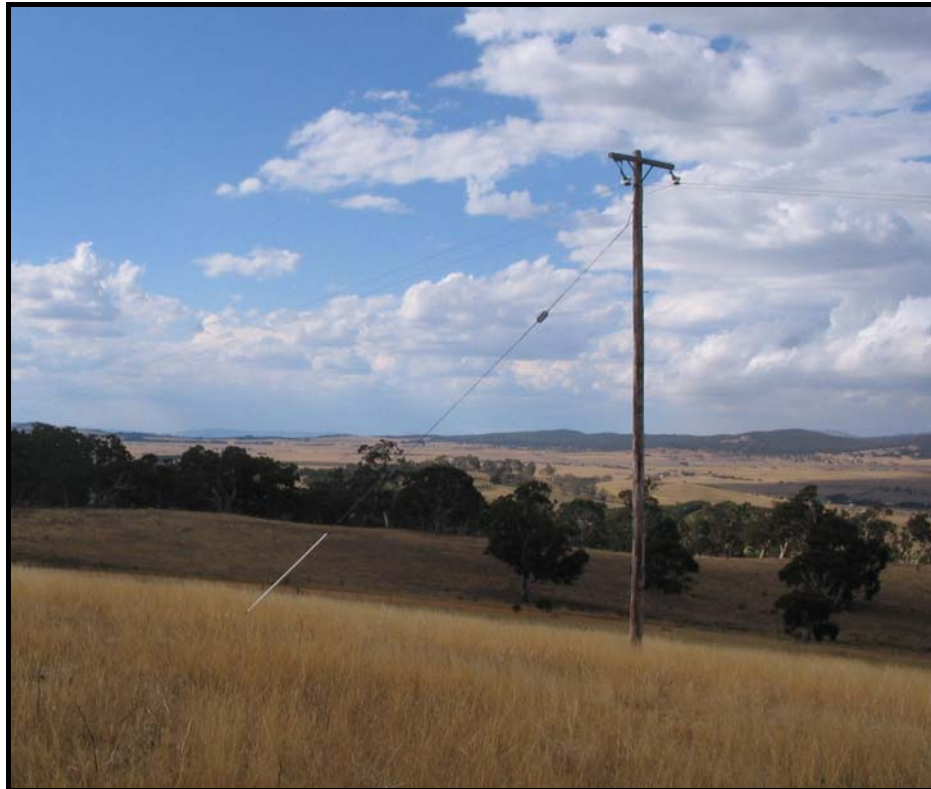
Figure 11: Example of a guy wire

Guy wires¹⁶ can also be difficult for pilots to see, even when the location of the wire is known. As shown in Figure 11, guy wires are generally located at either the end of a wire run or on a bend in the run to counterbalance the pull of the wires.

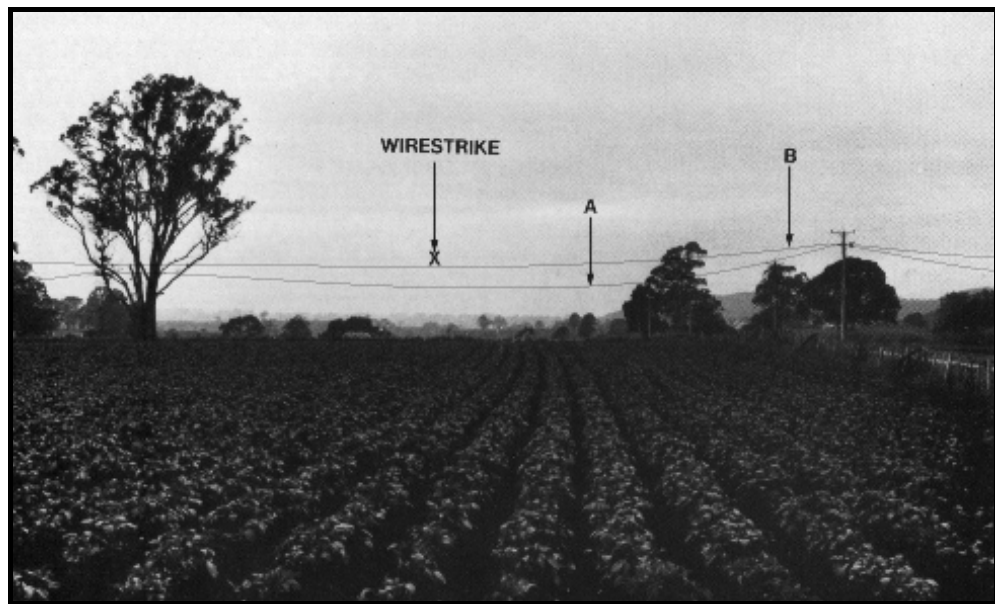
Figure 12: Focussing on high and low wires together can create the illusion that the higher wire (B) is further away than the lower wire (A)

Even if a wire can be seen, a pilot's ability to judge its position accurately may be reduced by a number of factors. For example, ambient temperature can change the location of the wire by causing the wire to sag or tighten, and windy conditions may cause sagging wires to be blown about (Harris, 2003). In addition, the ability to judge distance correctly can be distorted by optical illusions. As illustrated in Figure 12, higher wires appear to be further away when viewed in combination with lower wires. This effect only resolves at distances less than 100 metres, thereby leaving the pilot little time to react (Freeman, 1995).

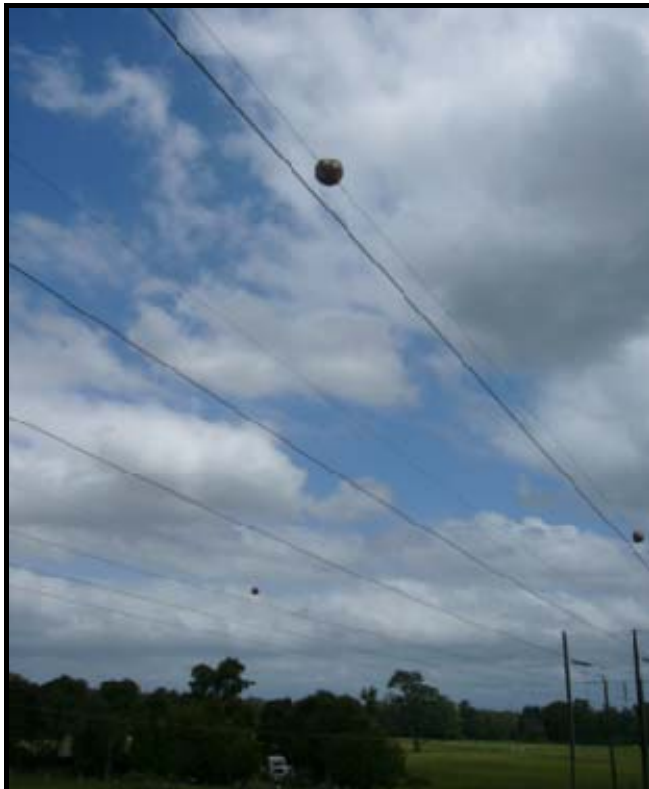
Figure 15: Example of wire markers mounted on a multi-strand powerline

Wire markers can be white, yellow, red or orange, and may be spheres, warning lights, marker panels or over-crossing markers in accordance with Standards Australia. The markers shown in Figure 14 and Figure 15 are red spheres.

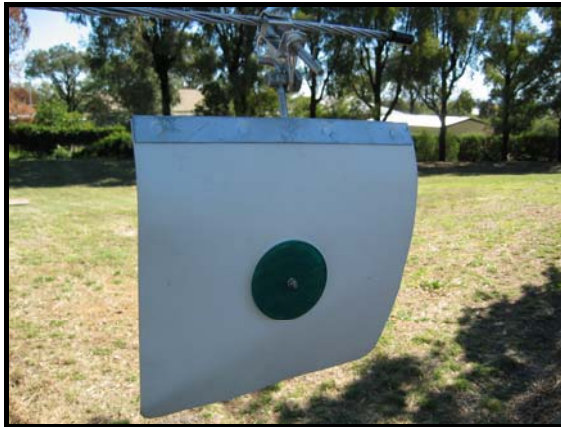
Figure 16: Example of a ‘flag marker’ used for aerial operations

More recently, Country Energy (New South Wales) has developed a cost effective powerline ‘flag marker’ to be used in areas such as crop spraying and harvesting, temporary or non-licensed aircraft landing areas, temporary air bases for fire fighting operations and external construction sites. As shown in Figure 16 and Figure 17, the marker is a mud flap shaped marker with a green retro reflector. The marker is designed to clip onto a range of conductors to increase visibility (A. Burman, personal communication, June 5, 2006).

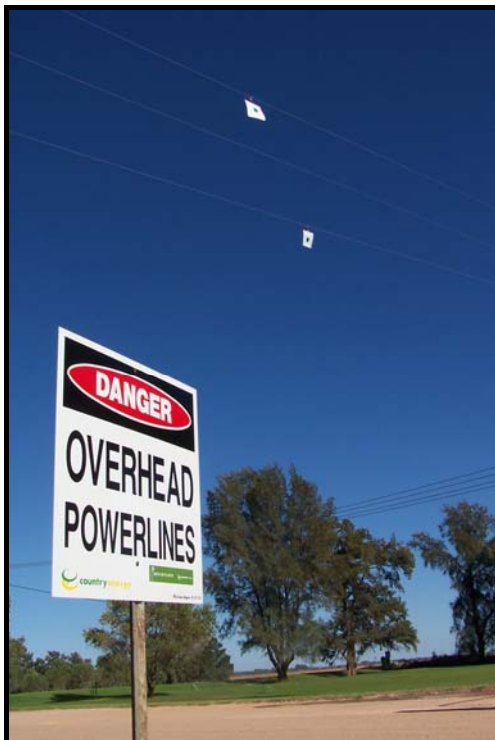
Figure 17: Example of a ‘flag marker’ used on overhead powerlines

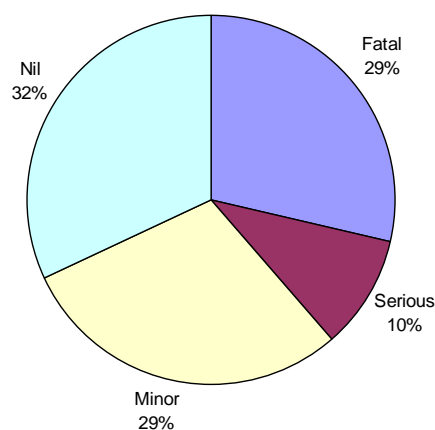
Figure 20: Percentage of wire-strike accidents by maximum level of injury, 1994 to 2004

Figure 20 shows the proportion of wire-strike accidents by the maximum level of injury received in relation to the accident. Nearly one third (29 per cent) of wire-strike accidents resulted in at least one fatal injury, 10 per cent resulted in at least one serious injury, and 29 per cent resulted in at least one minor injury. There were no injuries for 32 per cent of wire-strike accidents.

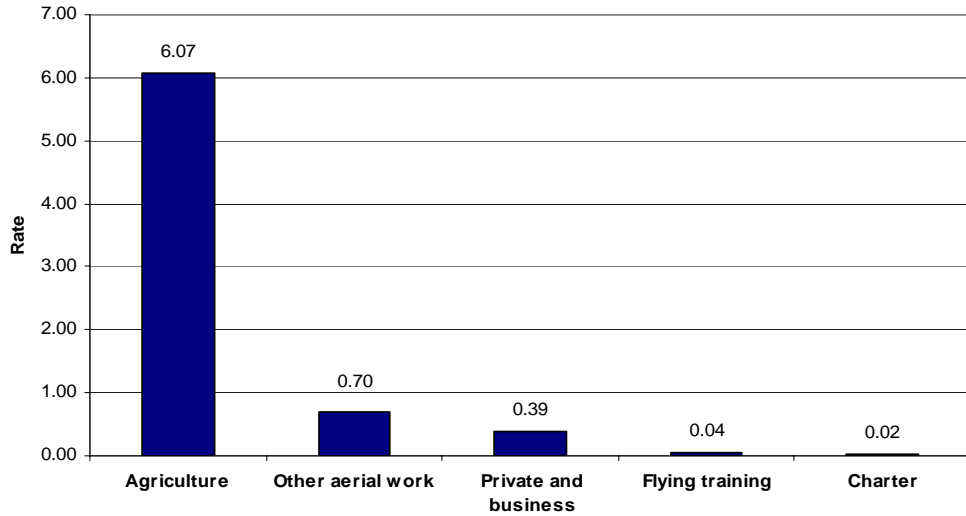
Figure 21: Wire-strike accidents for GA operations per 100,000 hours flown, 1994 to 2004

Figure 21 presents the rate of wire-strikes by flying category per 100,000 hours flown. Aerial agriculture operations experienced a rate of 6.07 wire-strike accidents per 100,000 hours flown. This was almost nine times the rate of accidents for the other aerial work category (0.7) and almost 16 times the rate for private and business flying (0.39). Furthermore, aircraft operating within the flying training category recorded 0.04 wire-strike accidents per 100,000 hours flown and the charter category recorded 0.02.

The large discrepancy between aerial agriculture operations and other flying categories is likely to be a reflection of the considerable amount of low-level flying conducted during aerial agriculture operations compared with other flying categories. Legitimate low-level flying also makes up a component of tasks completed by the other aerial work category operators and may explain the higher rate compared with the other categories. There was no data available to compare low-level flying risk exposure within each statistical category.

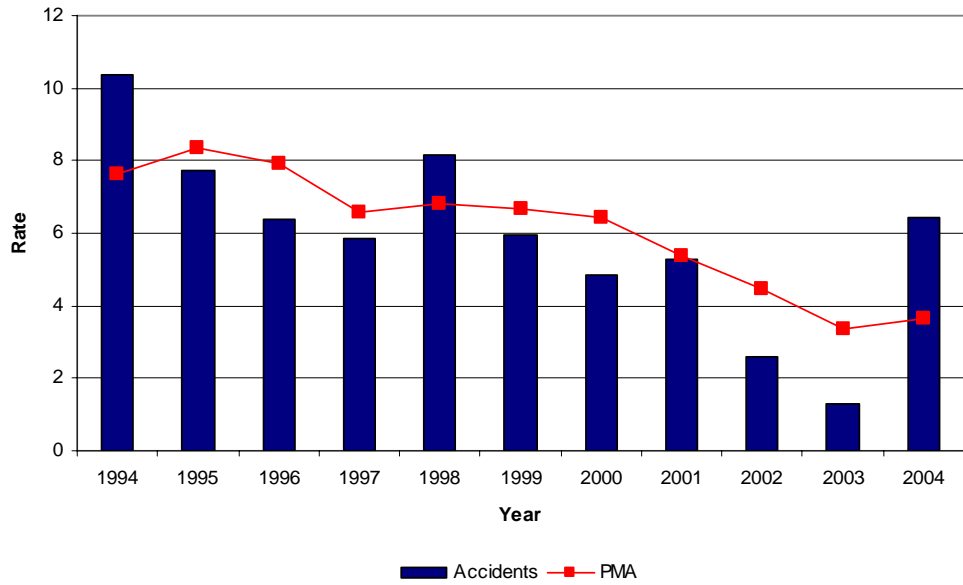
Figure 22: Wire-strike accidents for aerial agriculture operations per 100,000 hours flown, 1994 to 2004

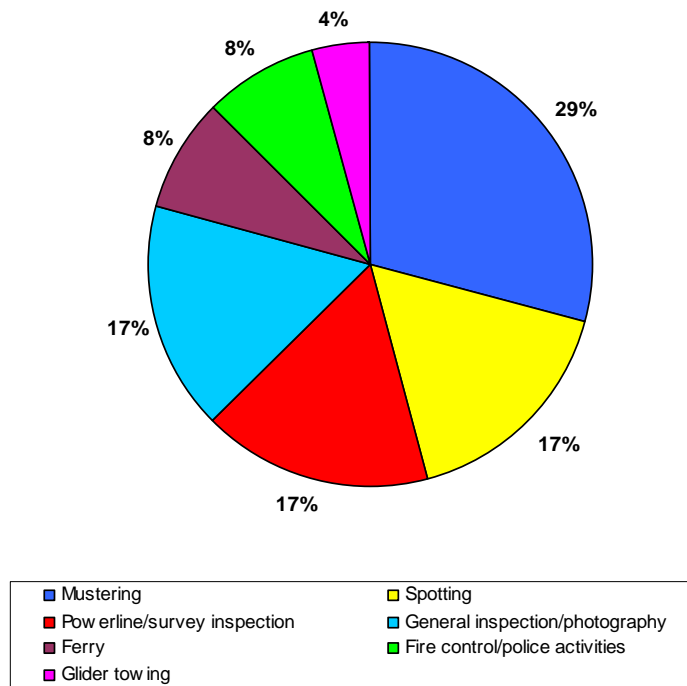
Figure 24: Distribution of wire-strike accidents for other aerial work operations, 1994 to 2004

Figure 24 shows the distribution of the 24 accidents among the varying subgroups within the other aerial work category. Like aerial agriculture, it is unsurprising that aerial mustering accounts for the greatest proportion of accidents within this category (29 per cent) given this activity is normally conducted very close to the ground. Powerline/survey inspection, aerial inspection/photography and aerial spotting each accounted for 17 per cent of wire-strike accidents within this statistical grouping over the reporting period.
