Safety Advisory Notice

Number: AO-2017-118-SAN-002

Are you protected from carbon monoxide poisoning?

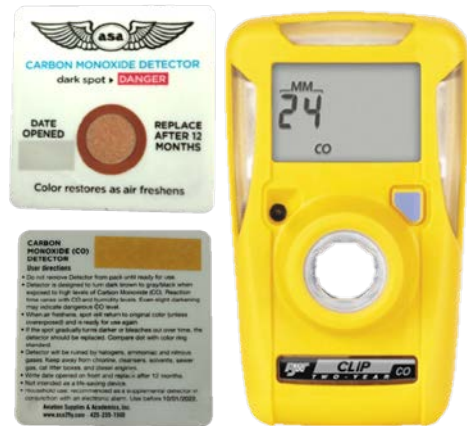
Passive chemical spot detector as carried in VH-NOO (L) with example BWC2R-M1025 active digital CO detector (R) (Source: ATSB)

As it is colourless, odourless and tasteless, CO is generally very difficult to detect. The aircraft was fitted with a disposable CO chemical spot detector. While these type of detectors are commonly used in general aviation aircraft, they have known limitations. They have a limited shelf-life when removed from their original packaging, which may be further affected by factors such as exposure to harsh direct sunlight, cleaning chemicals, and halogens. In addition, they are a passive device, which relies on the pilot regularly monitoring the changing colour of the detector to show elevated levels of CO. In contrast, electronic active CO detectors are designed to attract the pilot's attention through auditory and/or visual alerts when CO levels are elevated, so are more likely to be effective. These are now inexpensive and widely available. Had the pilot been made aware of the presence of CO, the pilot would have been able to take measures to reduce the risk to those on board. In addition, undetected CO in the cabin is a well-known risk that has been shown to have contributed to many fatal accidents across the world.

AO-2017-118-SAN-002: The use of an attention attracting carbon monoxide detector in the cockpit provides pilots with the best opportunity to detect carbon monoxide exposure before it adversely affects their ability to control the aircraft or become incapacitated. The ATSB strongly encourages operators and owners of piston-engine aircraft to install a carbon monoxide detector with an active warning to alert pilots to the presence of elevated levels of carbon monoxide in the cabin. If not provided, pilots are encouraged to carry a personal carbon monoxide detection and alerting device.
